SEISMIC HAZARD EVALUATION

1230 12TH STREET
MODESTO, CALIFORNIA

FINAL REPORT
May 2006

COMPLERE ENGINEERING GROUP, INC.
JOB NO. 25090

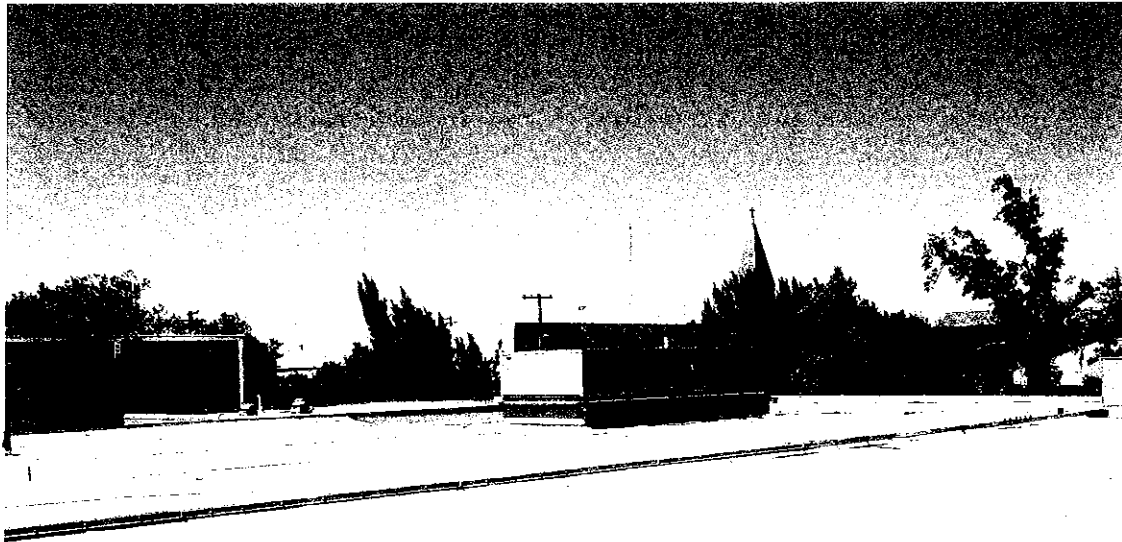
PHOTO NS-5 - HVAC AIR HANDLER ON ROOF
